DEPARTMENT OF TRANSPORTATION**DIVISION OF ENGINEERING SERVICES**

Quality Assurance and Source Inspection

Contract #: 04-0120F4Cty: SF/ALA Rte: 80 PM: 13.2/13.9File #: 1.28**WELDING INSPECTION REPORT****Resident Engineer:** Casey, William**Address:** 333 Burma Road**City:** Oakland, CA 94607**Report No:** WIR-028142**Date Inspected:** 09-Aug-2012**Project Name:** SAS Superstructure**OSM Arrival Time:** 700**Prime Contractor:** American Bridge/Fluor Enterprises, a JV**OSM Departure Time:** 1930**Contractor:** American Bridge/Fluor Enterprises, a JV**Location:** jobsite**CWI Name:** See Body of Report**CWI Present:** Yes No**Inspected CWI report:** Yes No N/A**Rod Oven in Use:** Yes No N/A**Electrode to specification:** Yes No N/A**Weld Procedures Followed:** Yes No N/A**Qualified Welders:** Yes No N/A**Verified Joint Fit-up:** Yes No N/A**Approved Drawings:** Yes No N/A**Approved WPS:** Yes No N/A**Delayed / Cancelled:** Yes No N/A**Bridge No:** 34-0006**Component:** OBG**Summary of Items Observed:**

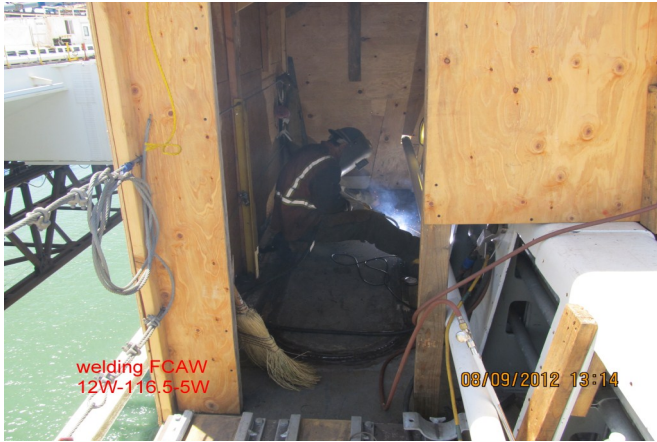
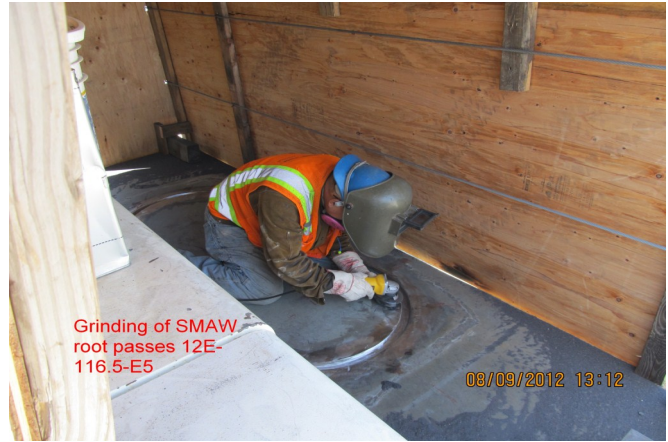
This QAI observed Jin Pei Wang (7299) preheating the circumference weld on Deck Access Hole 12W-PP116.5-W5. Mr. Huang was utilizing a rosebud style torch to achieve the Quality Control Documented, and randomly verified by this QAI preheat of 200F. Quality Control Technician Chris Concha was observed throughout the welding process checking preheat using a Rayteck Mini-Temp non-contact thermometer at set intervals.

QAI witnessed Jin Pei Wang welding Deck Access Hole 12W-PP116.5-W5 utilizing the Fluxed Cored Arc Welding process to the parameters of approved Welding Procedure Specification ABF-WPS-D15-3040-A-1. This QAI observed Chris Concha at various times throughout the shift documenting welding parameters using a Fluke Model 376 meter. This QAI randomly verified the welding parameters throughout the shift, at the time of verification the parameters were as follows: 271 Amps, 24 Volts. The parameters verified were within the range of the above-mentioned approved Welding Procedure Specification.

This QAI observed Guo Wu Chan preheating the circumference weld on Deck Access Hole 12E-PP116.5-E5. Mr. Chan was utilizing a rosebud style torch to achieve the Quality Control Documented, and randomly verified by this QAI preheat of 150F. Quality Control Technician Salvador Merino was observed throughout the welding process checking preheat using a Fluke Model 62 mini non-contact thermometer at set intervals.

QAI observed Guo Wu Chan welding deck access hole 12E-PP116.5-E5 utilizing the Shield Metal Arc Welding process to the parameters of the approved Welding Procedure Specification ABF-WPS-D15-1040-C1. This QAI observed Salvador Merino at various times throughout the shift documenting welding parameters using a Fluke Model 376 meter. This QAI randomly verified the welding parameters throughout the shift, at the time of verification the parameters were as follows: 176 amps. The parameters verified were within the range of the above-mentioned approved Welding Procedure Specification.
